New Hampshire Volunteer Lake Assessment Program

2003 Interim Report for Lake Monomonac Rindge

NHDES
Water Division
Watershed Management Bureau
29 Hazen Drive
Concord, NH 03301

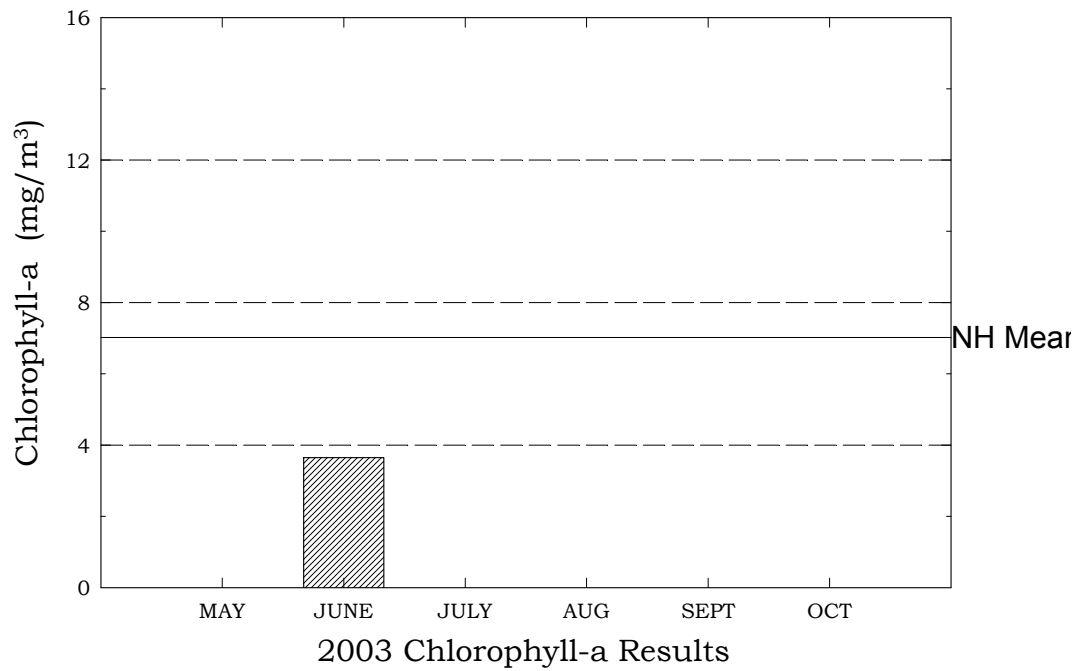
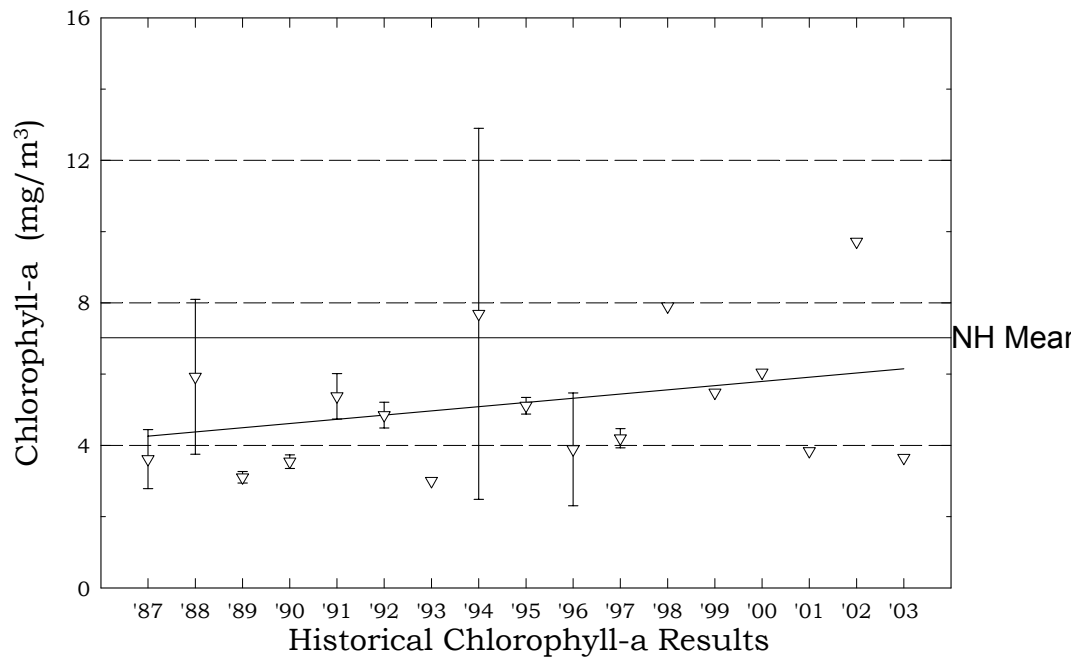
Figure 1. Monthly and Historical Chlorophyll-a Results

- **Figure 1 and Table 1:** The graphs in Figure 1 (Appendix A) show the historical and current year chlorophyll-a concentration in the water column. Table 1 (Appendix B) lists the maximum, minimum, and mean concentration for each sampling season that the lake/pond has been monitored through the program.

The current year data (the top graph) show that the chlorophyll-a concentration in June was **less than** the state mean.

Overall, visual inspection of the historical data trend line (the bottom graph) shows a **variable** in-lake chlorophyll-a trend, meaning that the concentration has **fluctuated** since monitoring began in 1987. In the 2004 annual report, we will again conduct a statistical analysis of the historical data to objectively determine if there has been a significant change in the annual mean chlorophyll-a concentration since monitoring began. As your monitoring group expands its sampling program in the future, we will be able to discern long-term trends with more accuracy and confidence.

While algae are naturally present in all lakes/ponds, an excessive or increasing amount of any type is not welcomed. In freshwater lakes/ponds, phosphorus is the nutrient that algae depend upon for growth. Algal concentrations may increase with an increase in nonpoint sources of phosphorus loading from the watershed, or in-lake sources of phosphorus loading (such as phosphorus releases from the sediments). Therefore, it is extremely important for volunteer monitors to continually educate residents about how activities within the watershed can affect phosphorus loading and lake/pond quality.

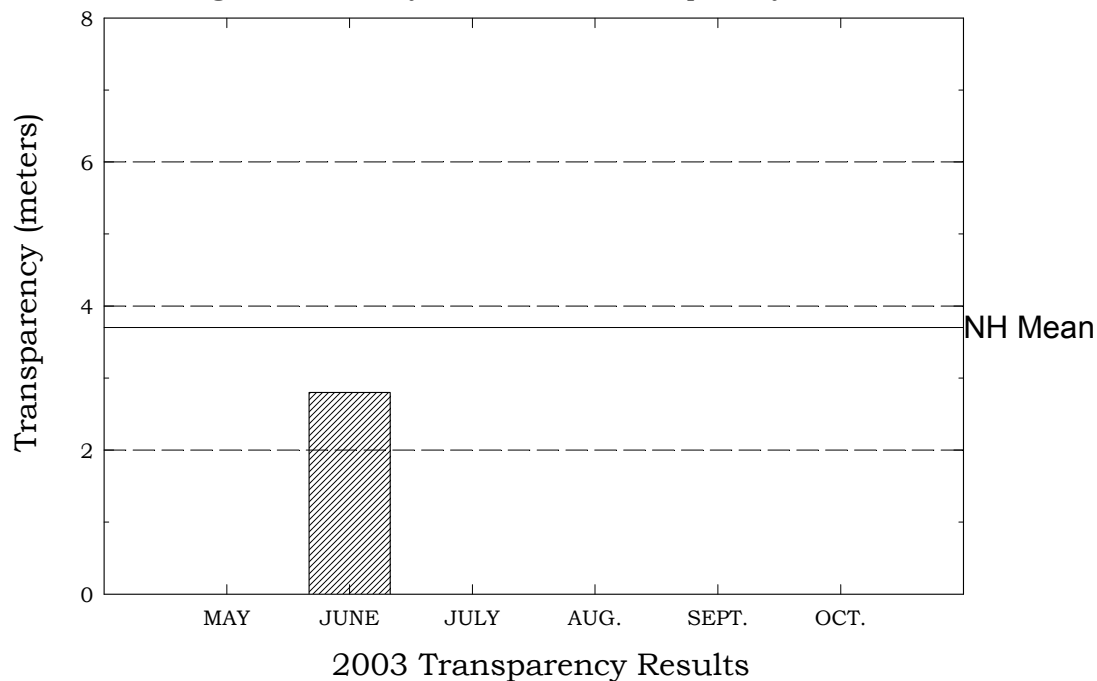
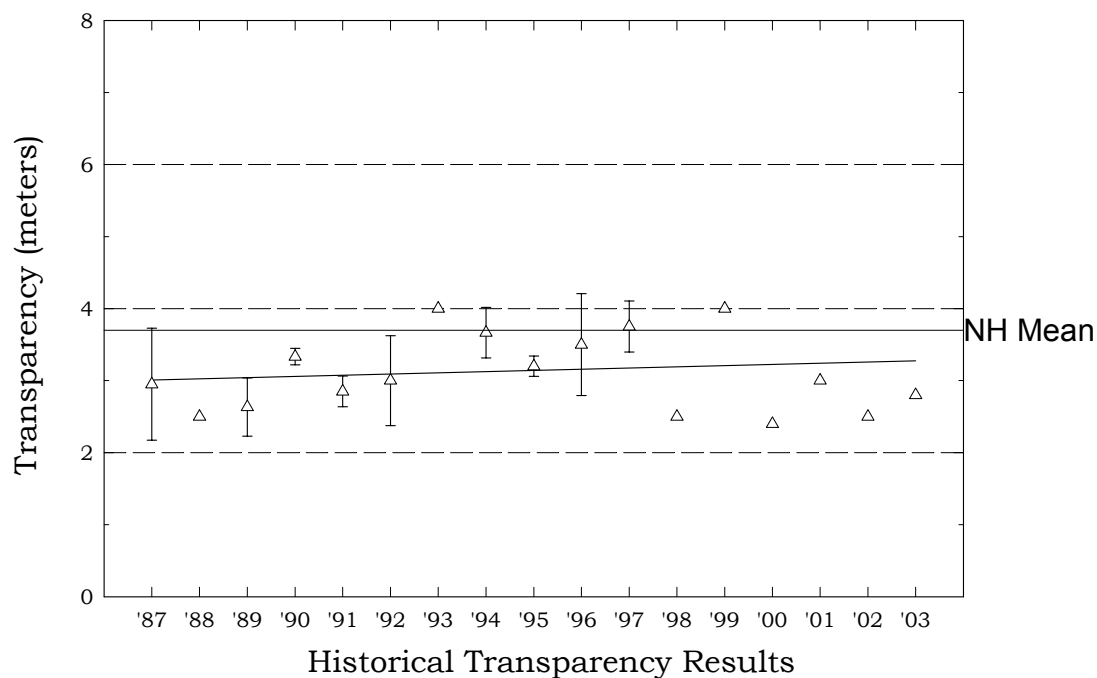
Figure 2. Monthly and Historical Transparency Results

- **Figure 2 and Table 3:** The graphs in Figure 2 (Appendix A) show historical and current year data for lake/pond transparency. Table 3 (Appendix B) lists the maximum, minimum and mean transparency data for each sampling season that the lake/pond has been monitored through the program.

The current year data (the top graph) show that the in-lake transparency in June was **less than** the state mean.

Overall, visual inspection of the historical data trend line (the bottom graph) shows a **variable** trend for in-lake transparency, meaning that the transparency has **fluctuated** since monitoring began. As discussed previously, in the 2004 annual report, we will conduct a statistical analysis of the historical data to objectively determine if there has been a significant change in the annual mean transparency since monitoring began.

Typically, high intensity rainfall causes erosion of sediments into lakes/ponds and streams, thus decreasing clarity. Efforts should continually be made to stabilize stream banks, lake/pond shorelines, disturbed soils within the watershed, and especially dirt roads located immediately adjacent to the edge of tributaries and the lake/pond. Guides to Best Management Practices designed to reduce, and possibly even eliminate, nonpoint source pollutants, such as sediment loading, are available from DES upon request.

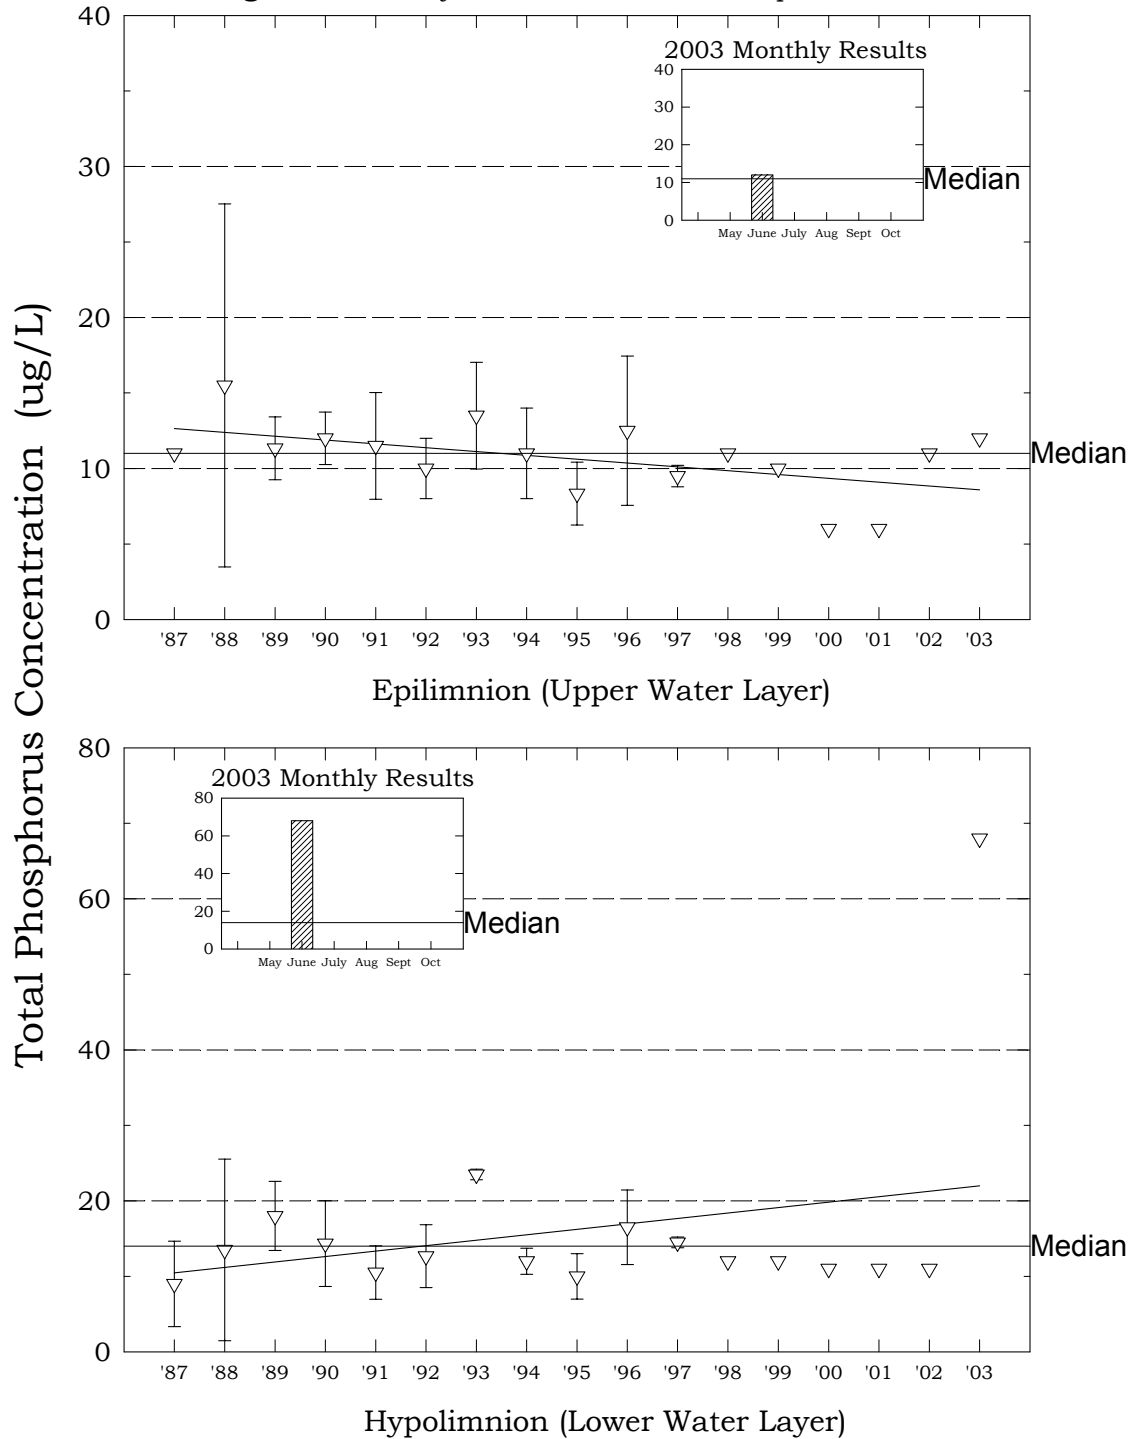
Figure 3. Monthly and Historical Total Phosphorus Data.

- **Figure 3 and Table 8:** The graphs in Figure 3 (Appendix A) show the amounts of phosphorus in the epilimnion (the upper layer) and the hypolimnion (the lower layer); the inset graphs show current year data. Table 8 (Appendix B) lists the annual maximum, minimum, and median concentration for each deep spot layer and each tributary since the lake/pond has joined the program.

The current year data for the epilimnion (the top inset graph) show that the phosphorus concentration in June was **slightly greater than** the state median.

The current year data for the hypolimnion (the bottom inset graph) show that the phosphorus concentration in June was ***much greater than*** the state median. Specifically, the June hypolimnetic concentration was **68 ug/L**, which is ***very high***, and is the ***highest*** phosphorus reading since monitoring began. The turbidity of the sample was *not* elevated (0.9 NTUs), which suggests that the lake bottom was *not* disturbed while sampling.

Overall, visual inspection of the historical data trend line for the epilimnion and the hypolimnion shows a ***variable*** phosphorus trend since monitoring began.

One of the most important approaches to reducing phosphorus loading to a waterbody is to continually educate watershed residents about its sources and how excessive amounts can adversely impact the ecology and value of lakes and ponds. Phosphorus sources within a lake or pond's watershed typically include septic systems, animal waste, lawn fertilizer, road and construction erosion, and natural wetlands.
